Questions and comments

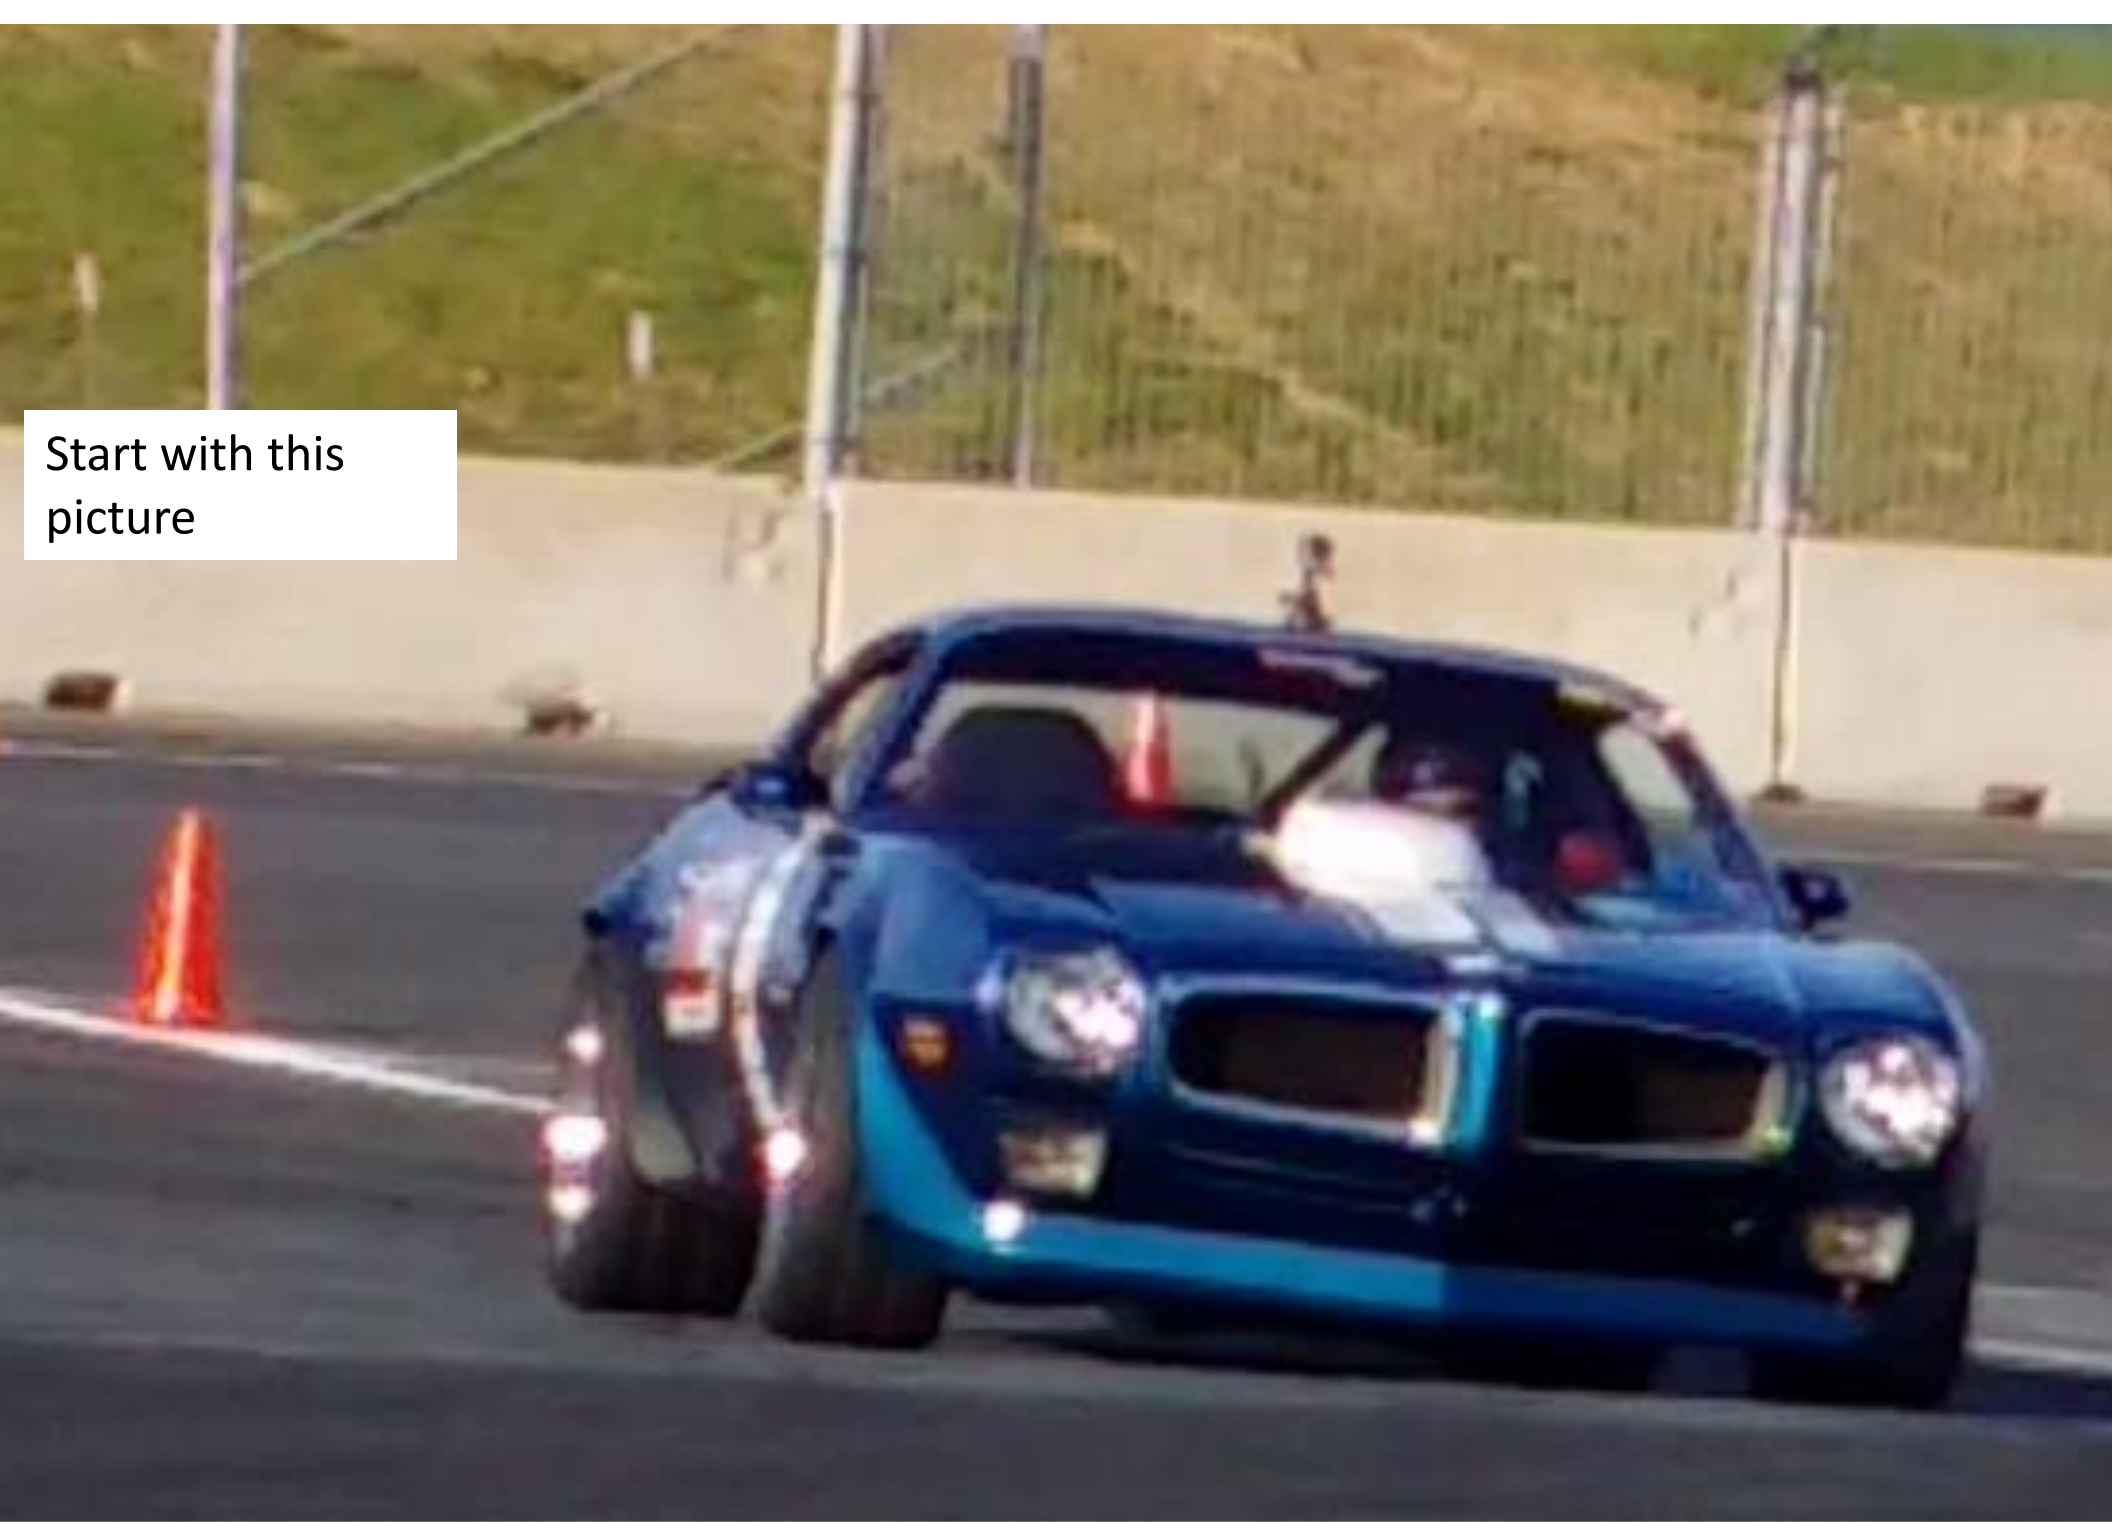
- Does the car feel like it understeers when you are holding constant speed throttle? This picture isn't the final answer, but it tends to indicate the car understeers. The fix would be a bigger front sway bar.

Start with this picture

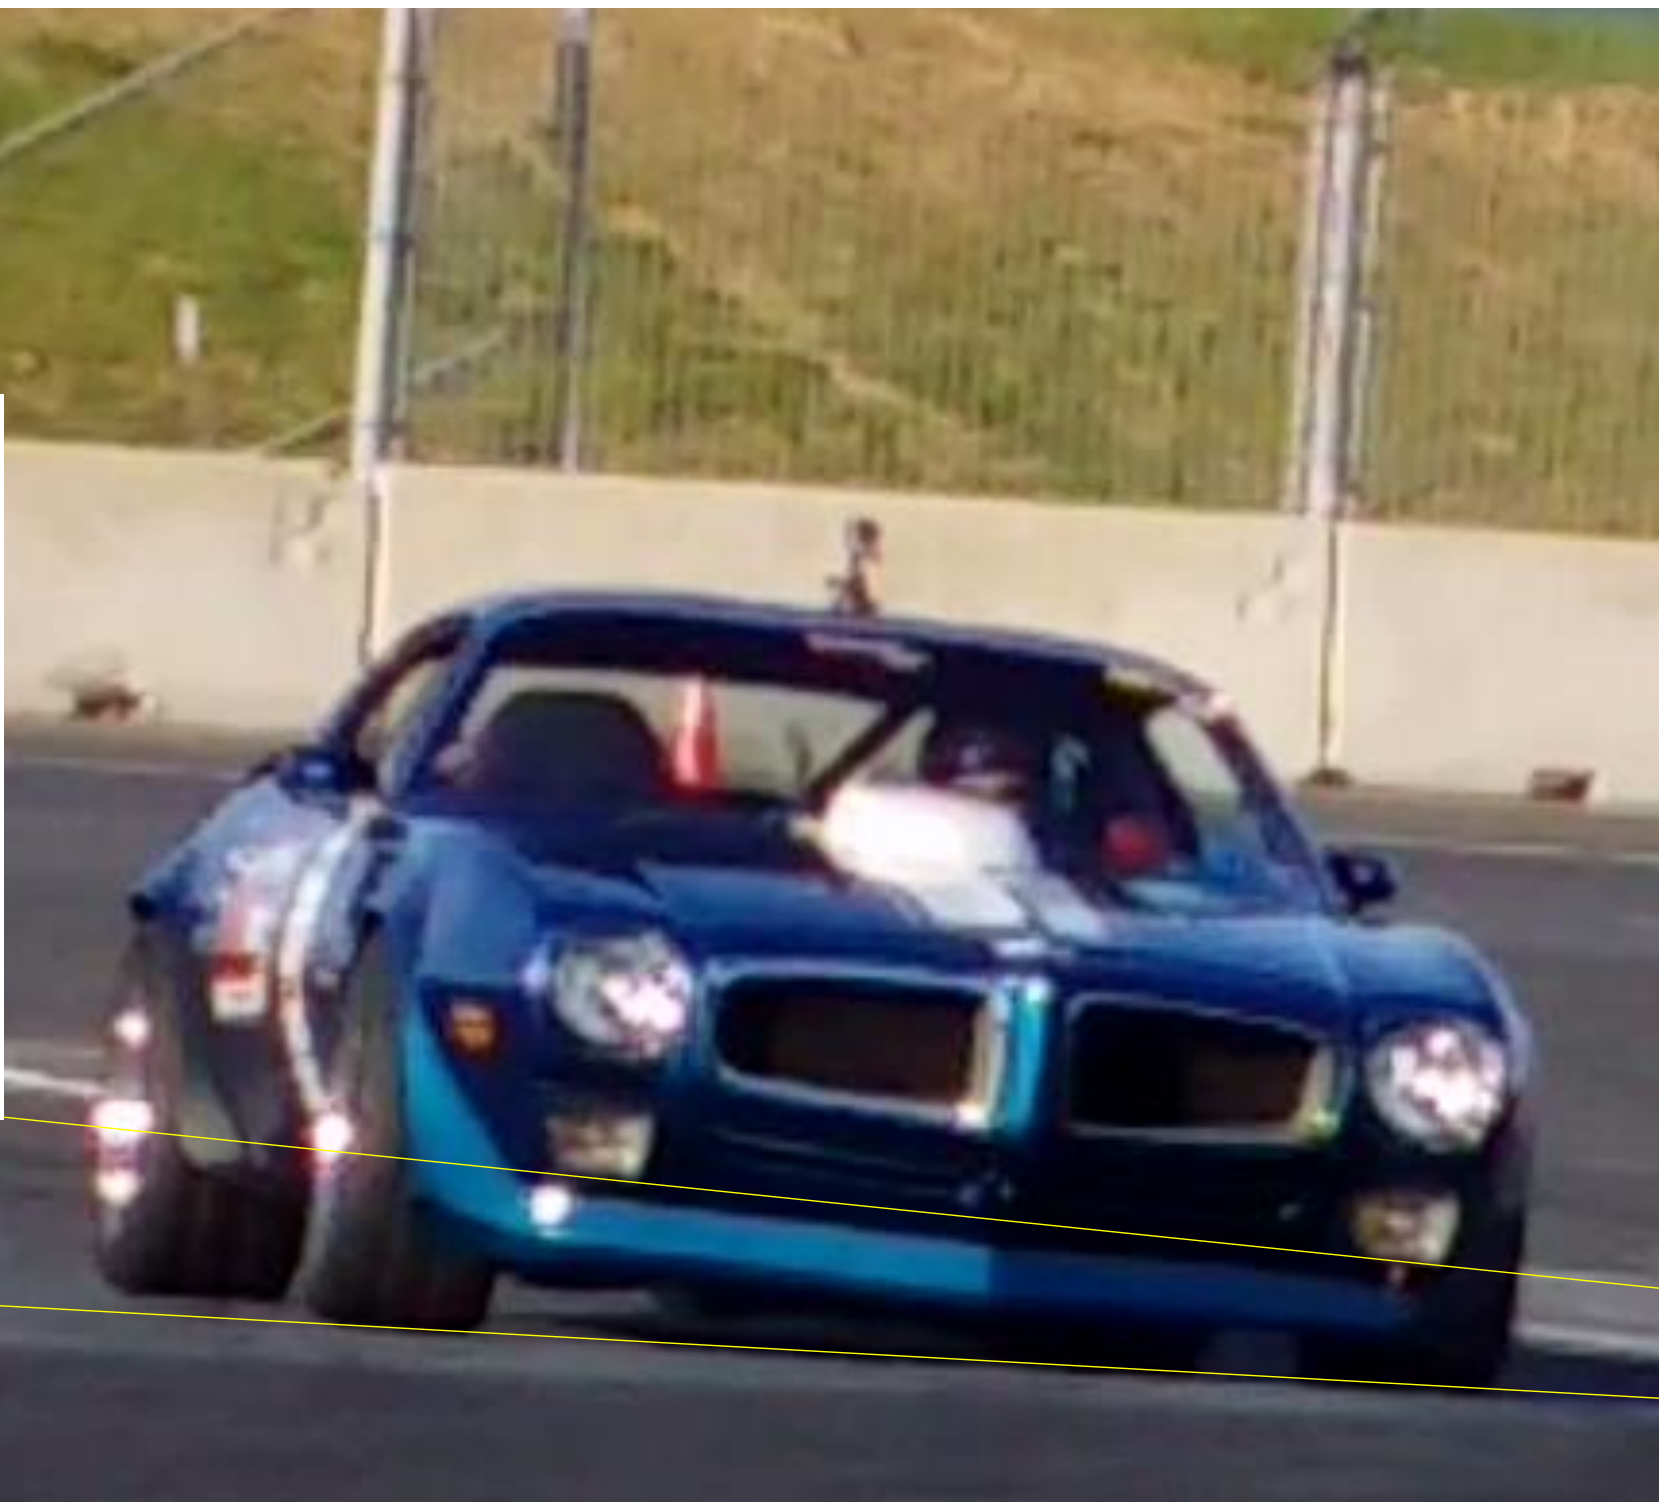
Draw one line where the tires contact the pavement, and another through the bottom of the parking lights as a vehicle reference line so we can measure the roll angle.

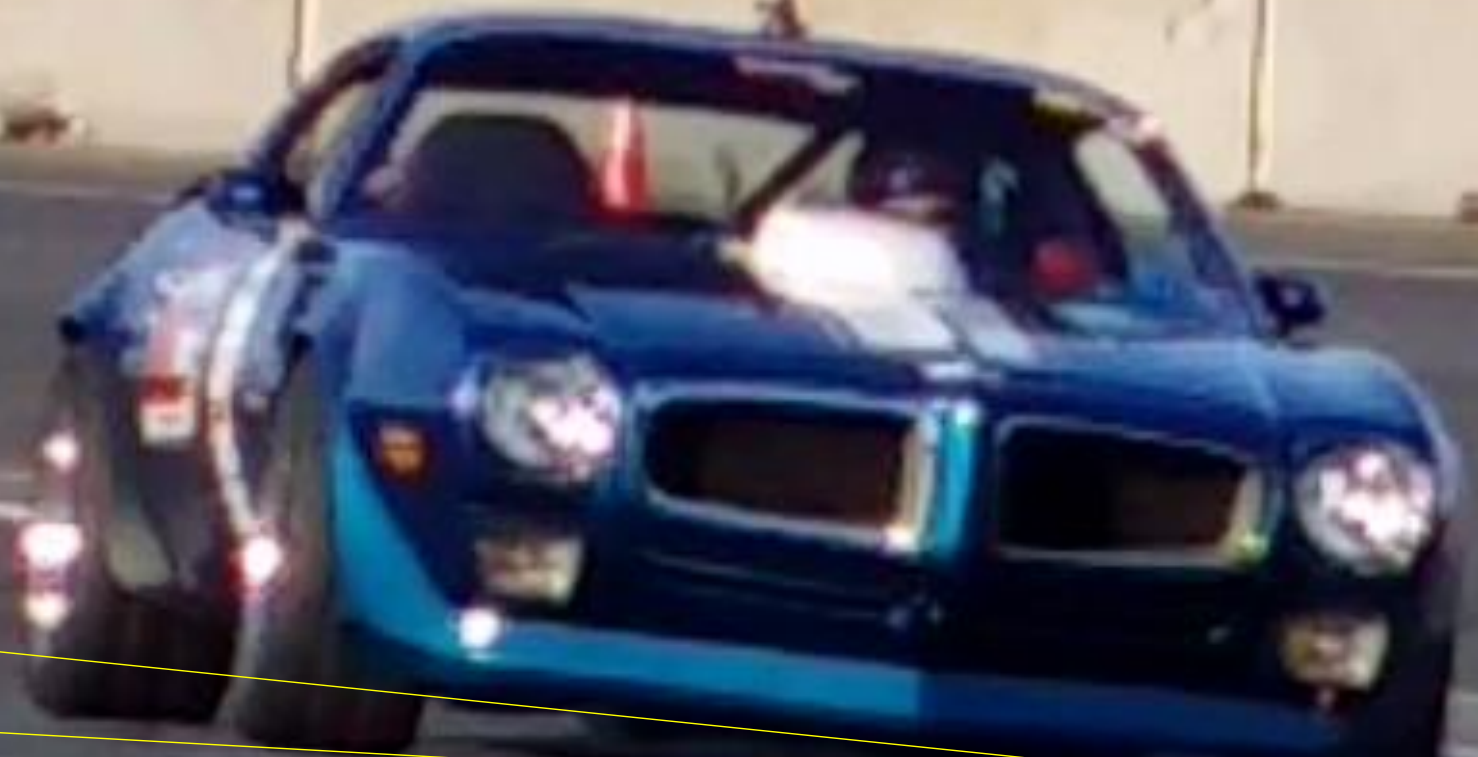
Next slide the
vehicle reference
line down to
make it easier to
measure the
arctangent

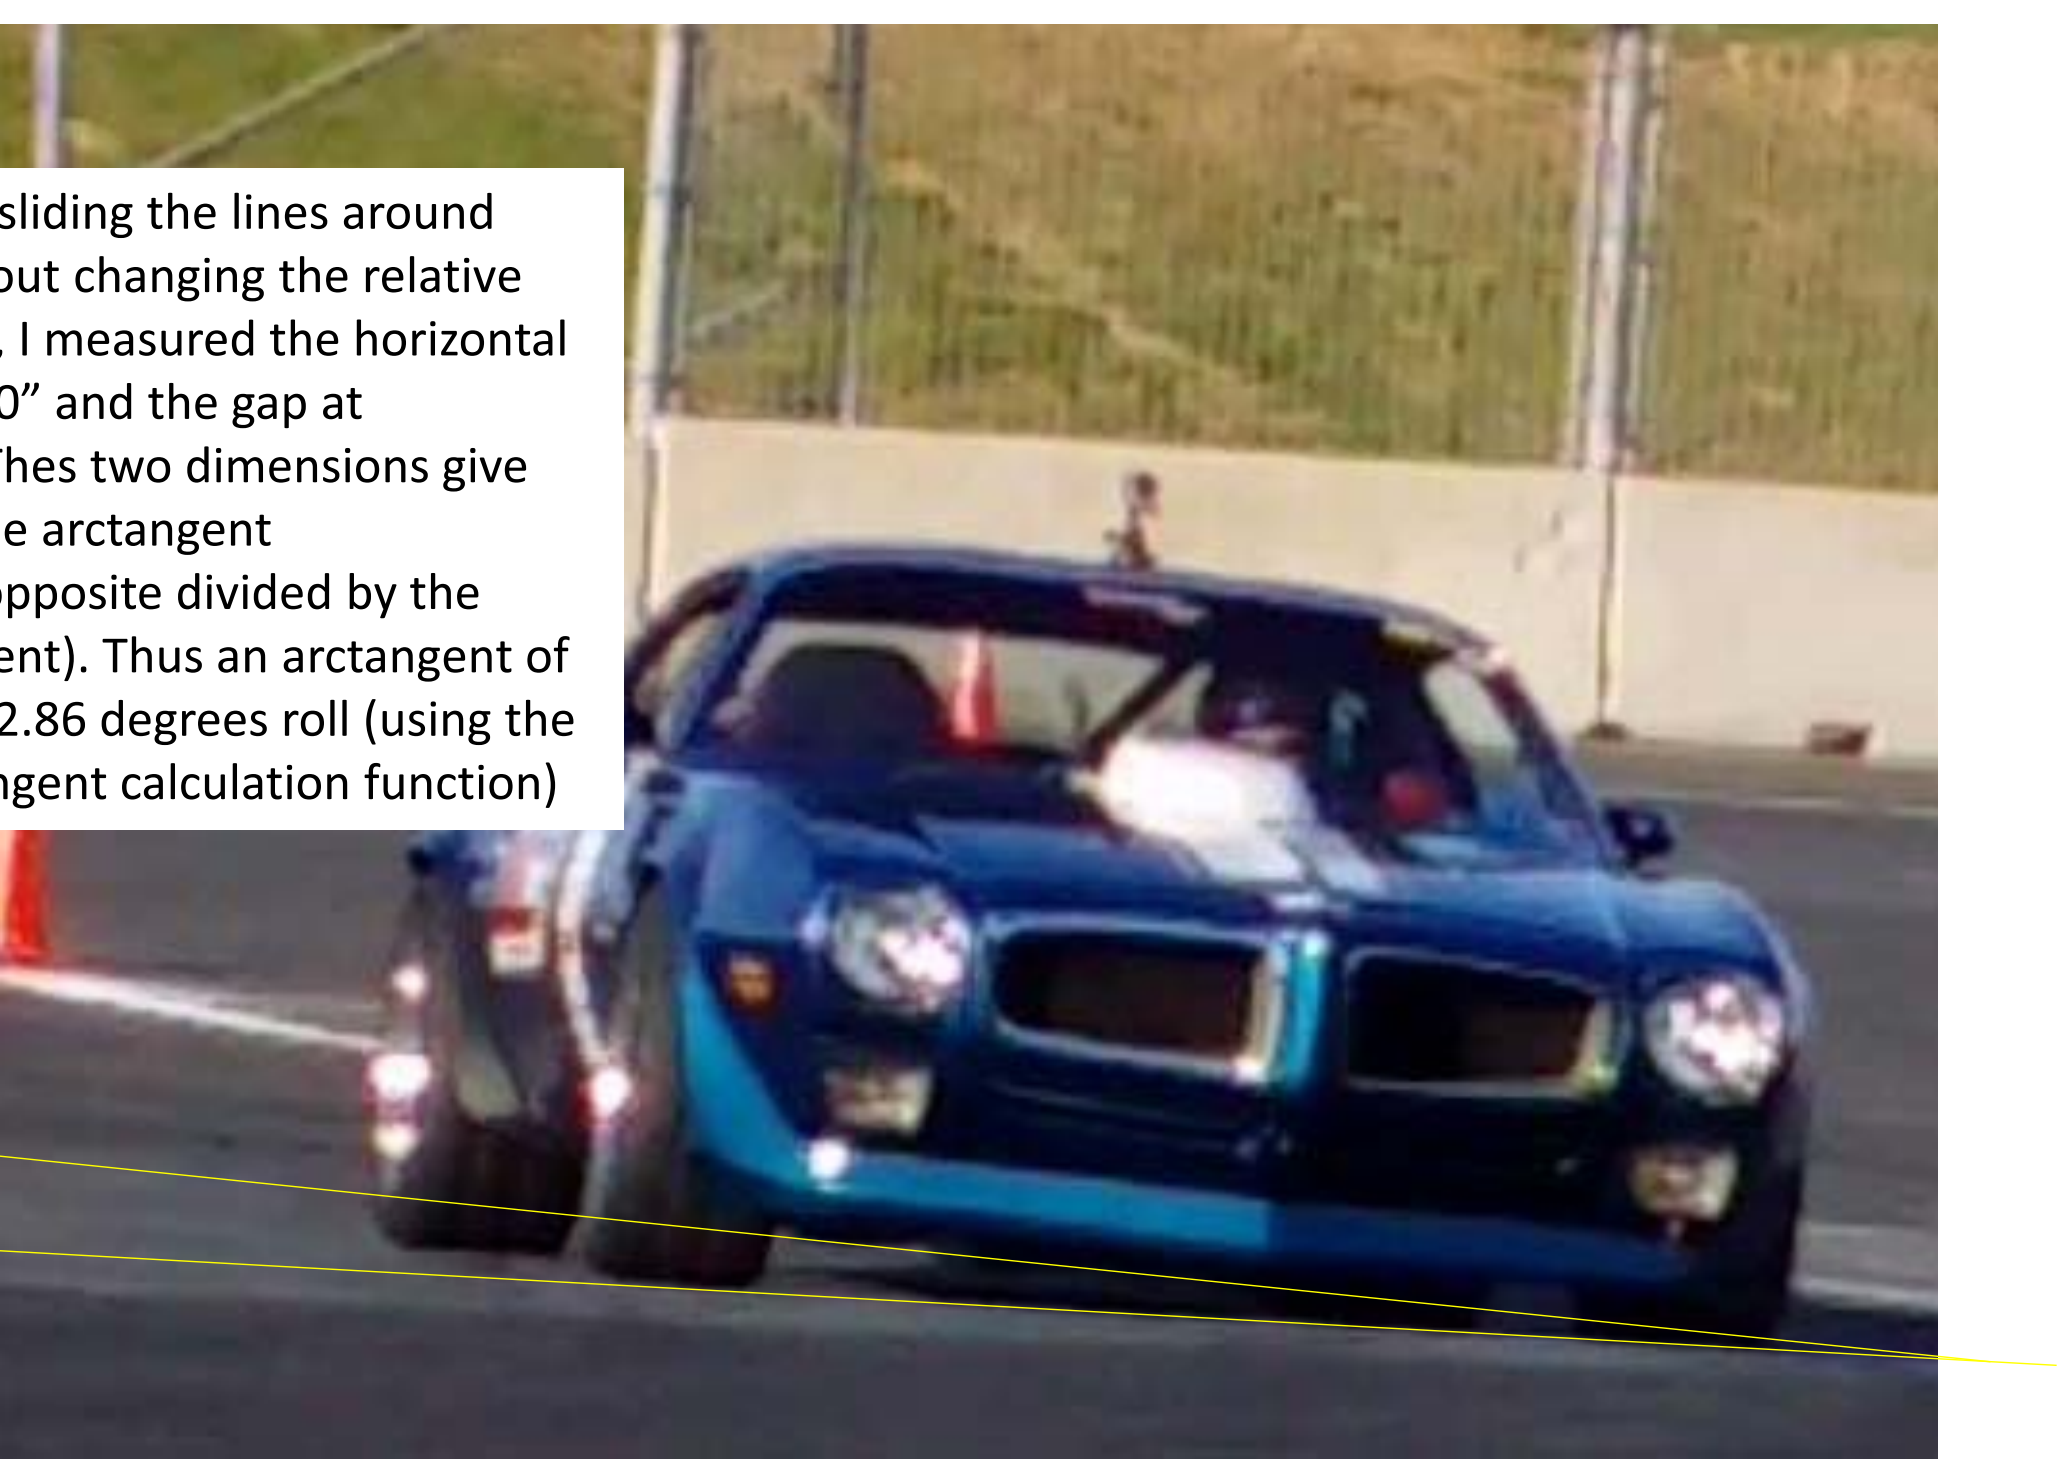
- 2.85 degrees of roll is in the range, but stickier tires will increase it. If the tires increase the lateral by 10% (1.0 to 1.1 G), then you will be ~ 3 degrees. My tentative conclusion is you will eventually need bigger bars front and rear, however, lowering the front (assuming there is a fix for the header clearance) may lower the roll since it will lower the center of gravity a bit.

sliding the lines around
without changing the relative
. I measured the horizontal
0" and the gap at
these two dimensions give
the arctangent
opposite divided by the
(adjacent). Thus an arctangent of
2.86 degrees roll (using the
arctangent calculation function)

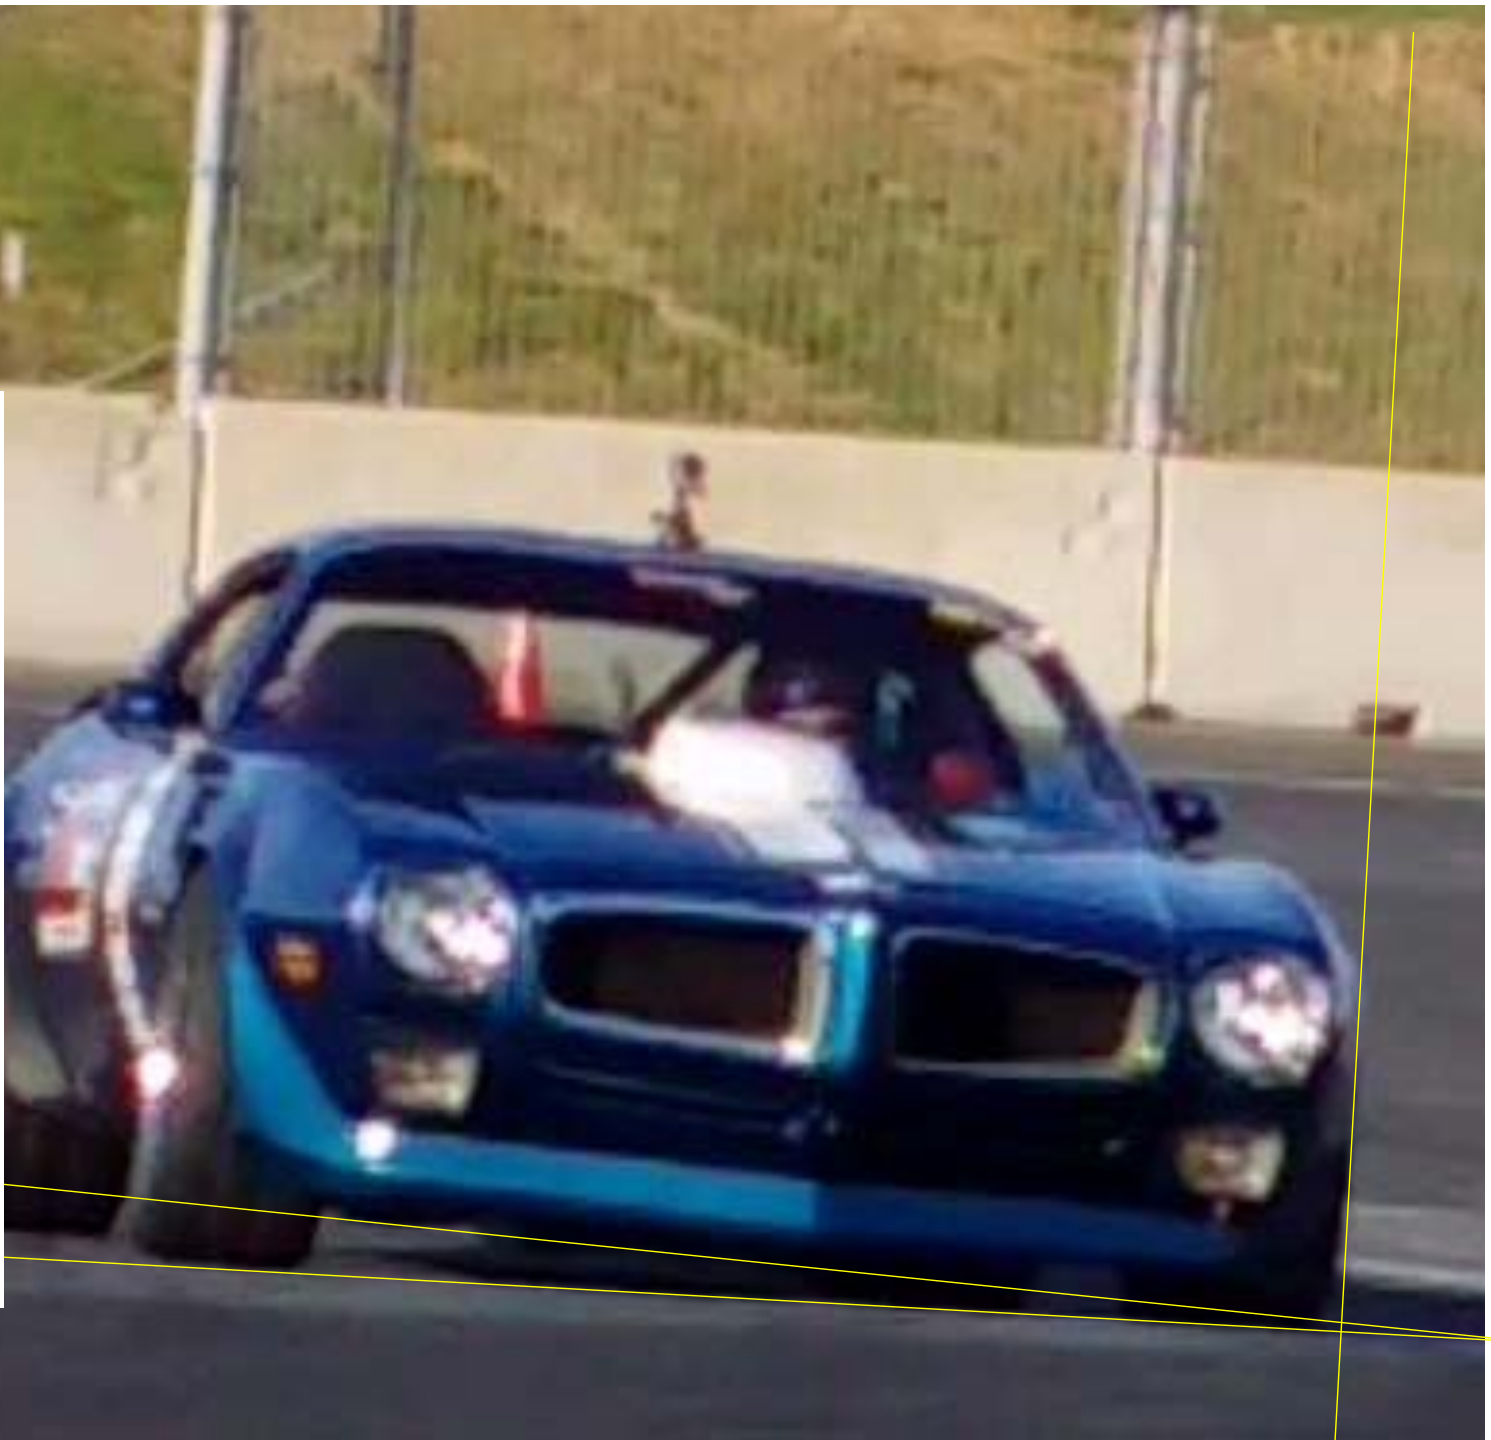
- It looks like from the picture like the spindle doesn't have enough negative camber gain under compression. This is confirmed by the fact you can use $-3\frac{1}{2}$ degrees camber and not wear the inside edges of the tire.

Outside tire looks like it has too much load on outside of tire, meaning the spindle does not have enough camber gain. A taller spindle would be better.

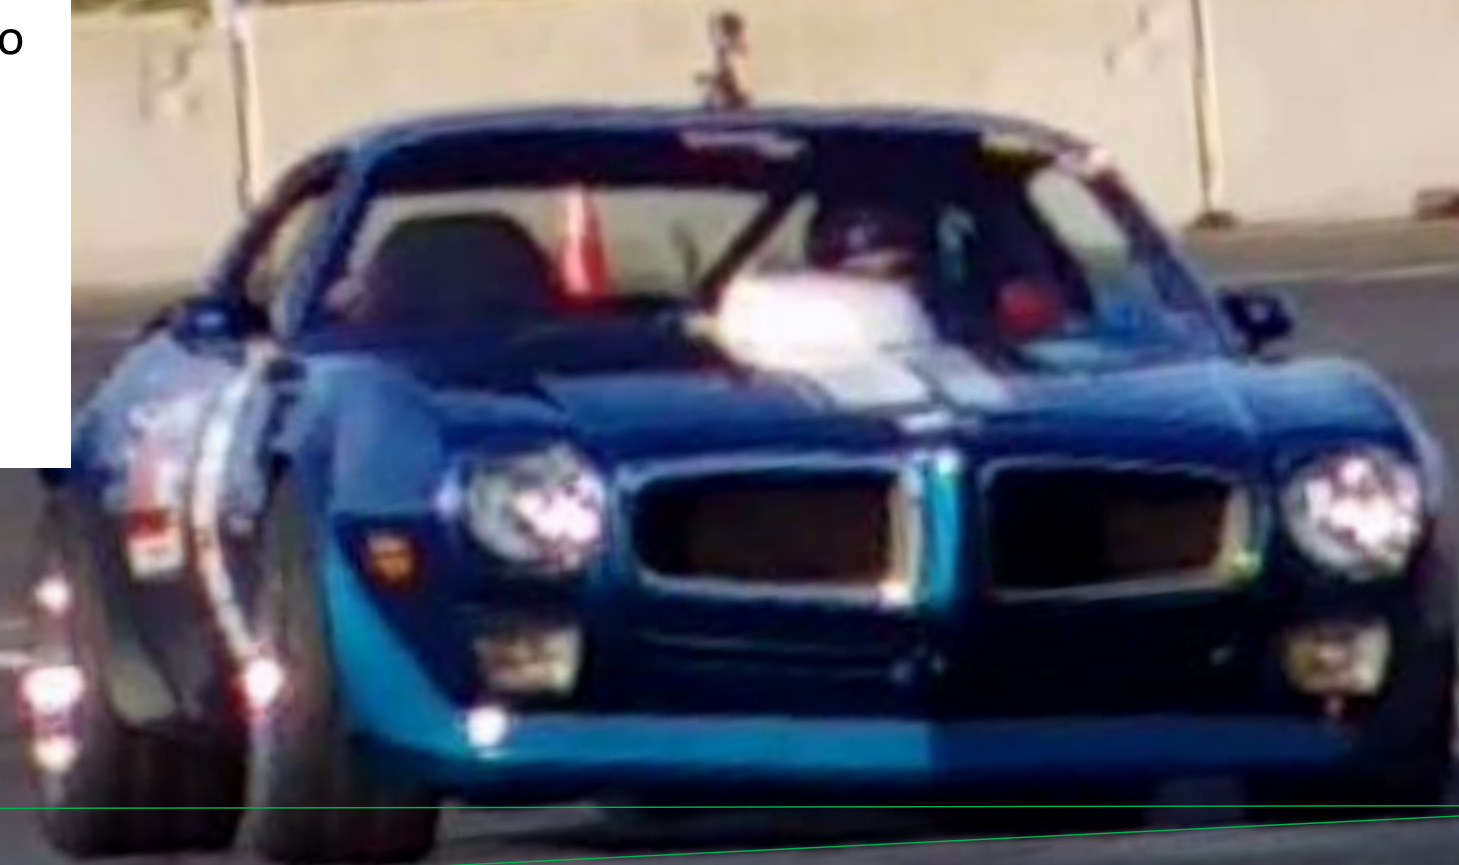
Same lines, color changed to green to try to make them more visible.

Rotate picture so that the pavement reference line is horizontal.

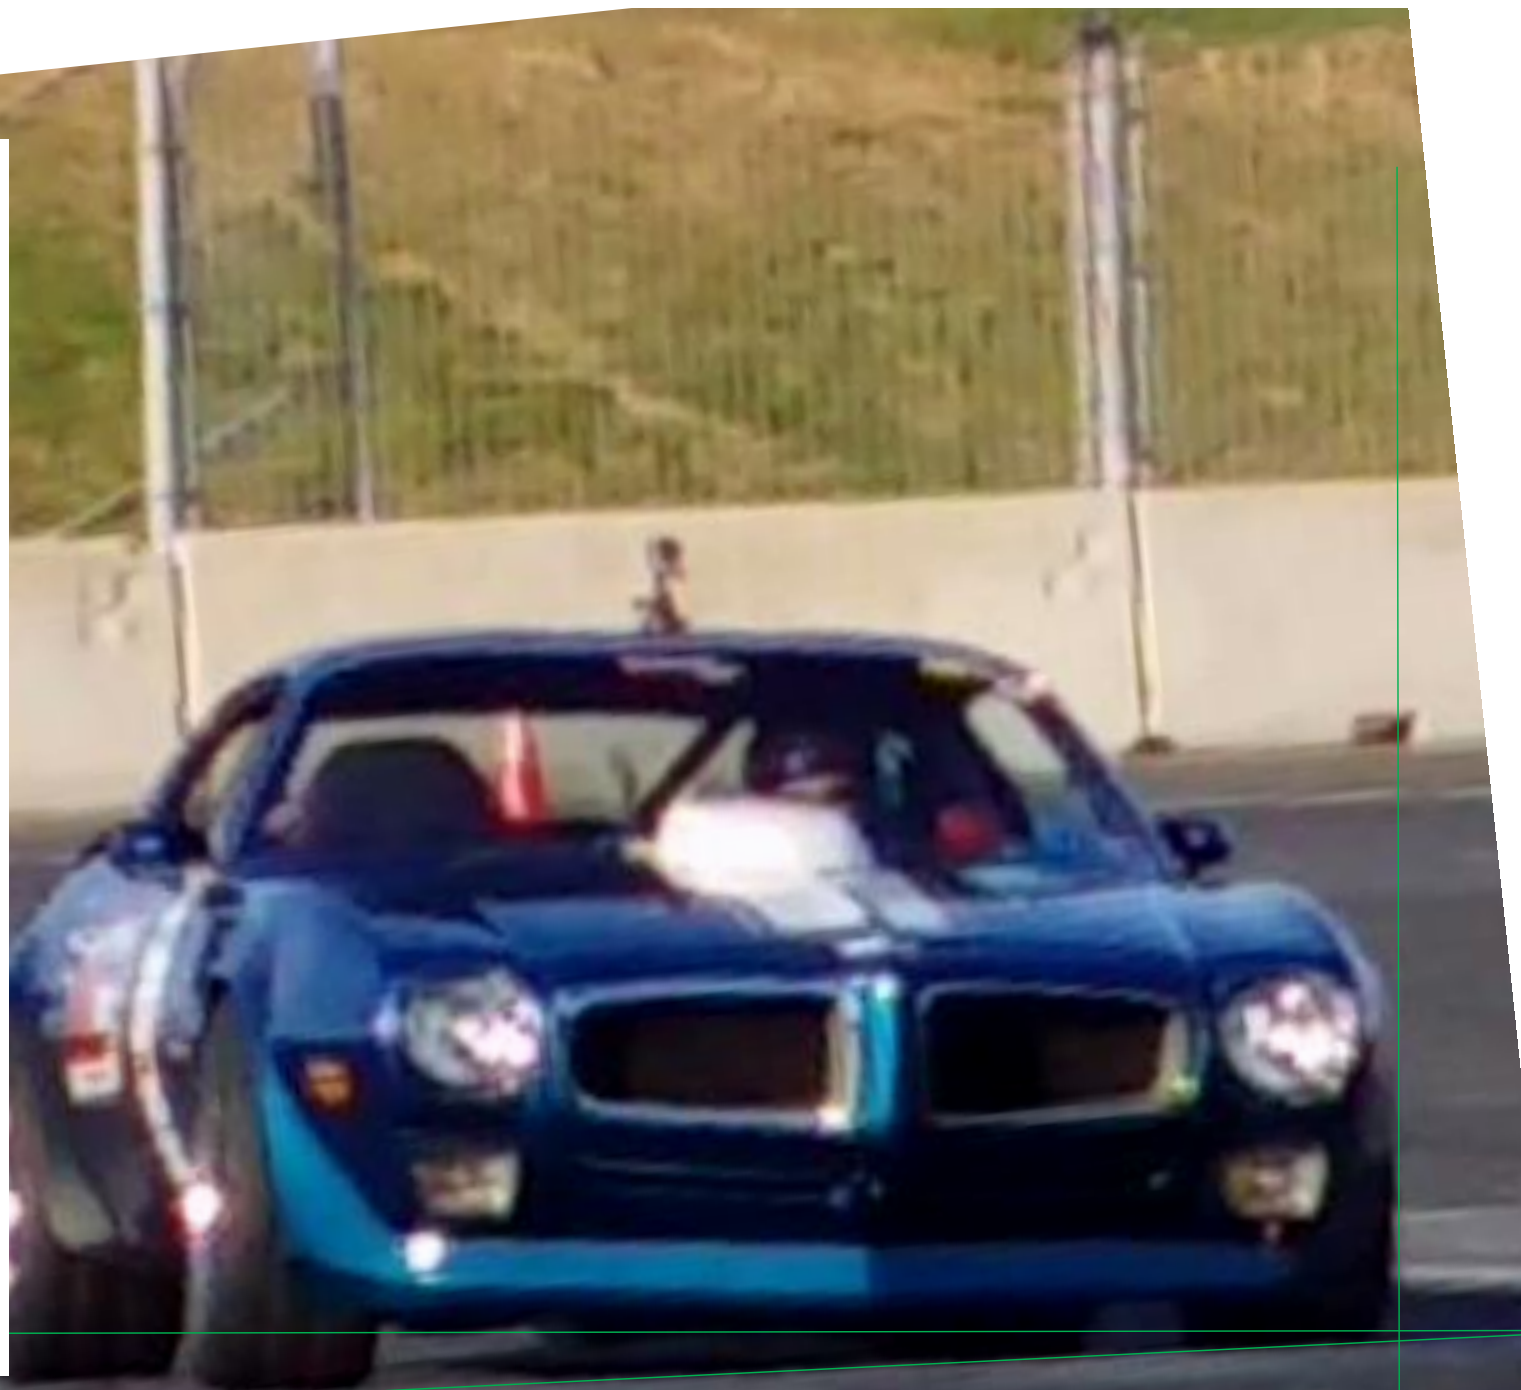
Add a vertical line perpendicular to the pavement reference line. so we can eyeball whether the outside tire is contacting the pavement exactly even, or slightly negative camber. This picture shows the car might be positive camber on the outside, which is sub optimal. See comments on first page.
